FREEZE-THAW PERFORMANCE

77 winters · 9 sites · 0 defects

LL-TEQ™ freeze-thaw performance

This document is the **marketing summary** of the technical dossier "*LL-TEQ — Freeze-Thaw Performance*," dated May 19, 2026 and prepared by an independent engineer at LL-TEQ's request.

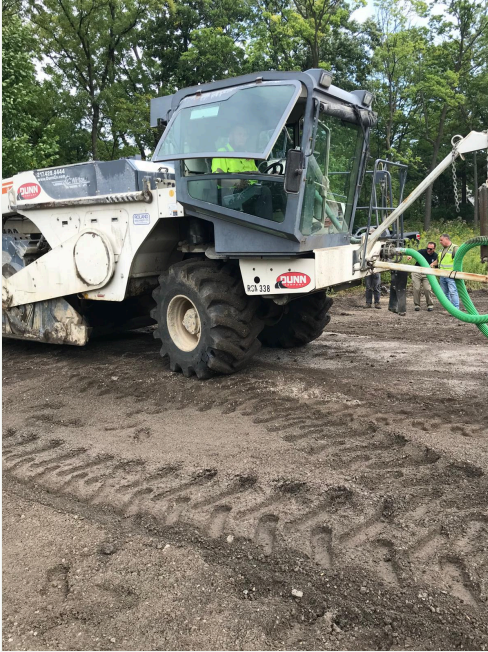
| Cold recycling in place (*Cold Recycling*)

Four sites treated: Benton Harbor, Alexandria, Glenview, Bessemer. The reclaimer integrates the existing degraded bituminous mix and the underlying granular gravel base into a cohesive layer of ≈ 150 mm (6 in), with no interface or stratification.

Use case: rehabilitation of an existing degraded pavement.

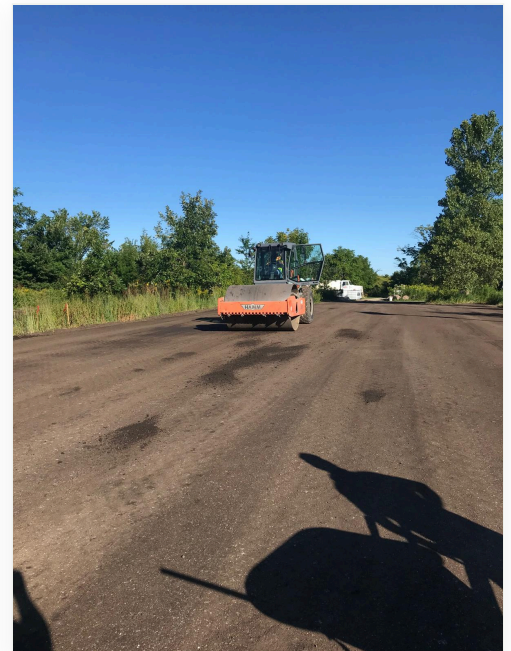
| In-place native-soil stabilization (

In-place Soil Stabilization)

Five sites treated: Rockford, East Chicago, Elgin, Bridgeport, Big Bear Lake. The LL-TEQ layer alone constitutes the pavement, at ≈ 150 mm (≈ 200 mm at Bridgeport for the dossier's most demanding load). No added granular base or sub-base.

Use case: new pavements with no prior conventional structure.

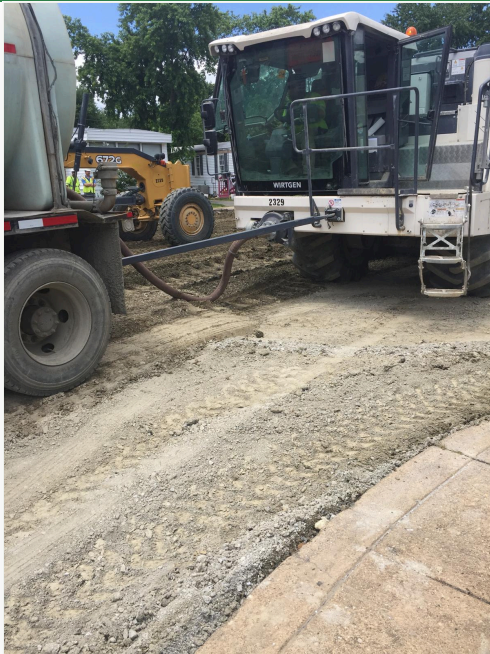
Flagship site — Bessemer, Alabama

Placed in service in **April 2016** by cold recycling in place. **10 cumulative winters**, humid subtropical climate (*Cfa*), ~1,300 mm/yr rainfall and silty native soil. The pairing of moisture + fine soil documents LL-TEQ's long-term durability under a regime with frequent oscillations around 0 °C.

No cracking, no alligator cracking, no heave, no potholes, no rutting. Surface wear "*slight for ten winters of exposure.*"
